## Elevator trips emergency generator breaker

### Application Note

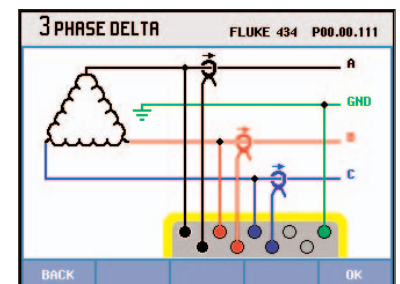
Facilities used a three-phase Power Quality Analyzer to examine the elevator system's operating characteristics during an emergency power system test. First, they connected the analyzer to the circuit and used the setup function to make sure all the connections were accurate.

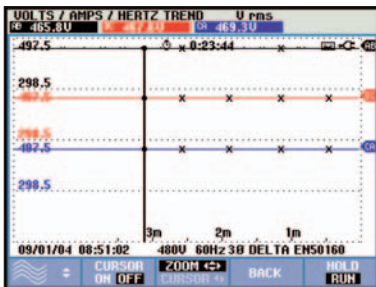
Looking at the trended Volts/ Amps/Hertz data, the technicians could see where the breaker tripped, but they didn't see any event data that would have caused it. This problem was too fast for regular readings.

All three phase voltages go to zero until the circuit breaker is reset.

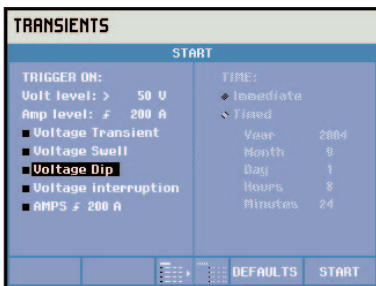
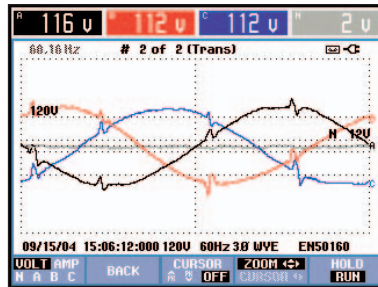
Sample screen.

The team switched to the analyzer's Transients function, so they could see transients as fast as 5 microseconds, started recording and conducted the generator test. When the breaker tripped this time, a transient was clearly evident.

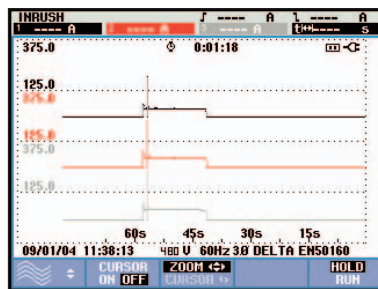
They selected the Inrush Currents function on the analyzer and reviewed the current levels for all the loads managed by the emergency power system. The technicians did see an inrush event. The inrush magnitude was within the equipment specifications ... but why was the inrush event occurring when the system was already operational?

For some reason, the elevator system wasn't sensing the power fault condition. So, every time emergency power was reapplied, the elevator system started to perform a normal start-up – and that much inrush and start-up current on top of normal operations exceeded the rating of the power emergency protection circuit breaker.

A simple adjustment to the elevator power fault sensing circuit allowed the new system to properly perform the individual elevator car power failure procedure. In the process, facilities verified the protection circuit breaker settings and adjusted them back to the proper set points.
